**Flood Control Project Maintenance**  
**2019 Structure Summary Report**  
**Overall Unit and Item Ratings**

**Turlock Irrigation District Gomes Lake**

**Flood Control Project Maintenance****Unit Cover Sheet****2019 Pumping Plant Inspection Results****Turlock Irrigation District Gomes Lake**

**Levee Inspection Report By Mile - Structure 2019**

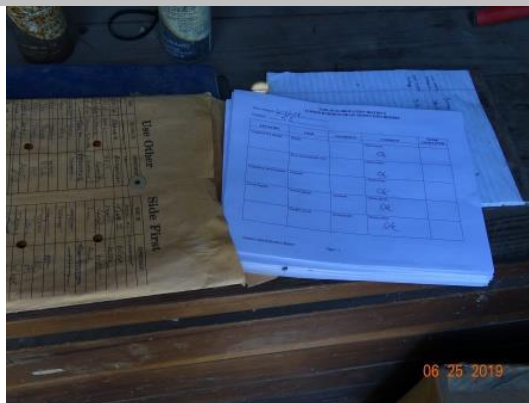
Photo 1 of 2 : ST\_2019\_NA0065\_15\_1\_20190627\_00019.jpg

LM Start	0.00	Rating **	A	Issue No.	1
LM End	0.00	Issue Type +	Ma	Location *	
Category	Pump Stations			GPS Latitude/Longitude	
				Start	End
Item	Operating Log			37.481567°	37.481567°
				-121.046617°	-121.046617°
DWR ID	DWR_NA0065_15_t_2012_1				
Action/Comments					
Inspector Comments: An operation log was present at the plant and the log was up to date.

View of operating log. (2019)

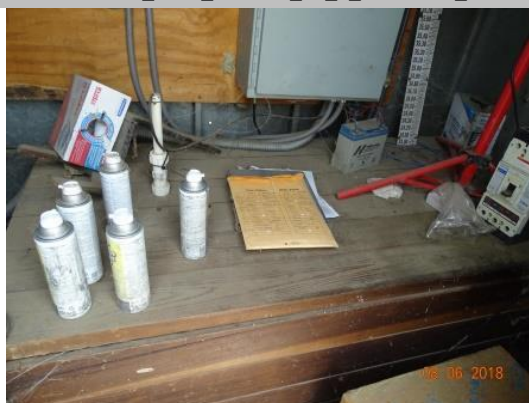
Photo 2 of 2 : ST\_2019\_NA0065\_15\_1\_20190613\_00001.jpg

View of the operating log. (2018)

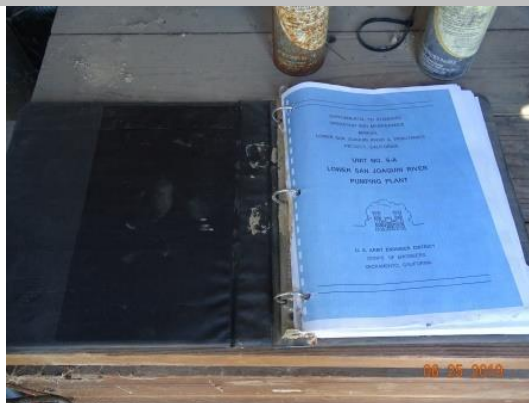
Photo 1 of 1 : ST\_2019\_NA0065\_15\_2\_20190627\_00020.jpg

LM Start	0.00	Rating **	A	Issue No.	2
LM End	0.00	Issue Type +	Ma	Location *	
Category	Pump Stations			GPS Latitude/Longitude	
				Start	End
Item	Operation & Maintenance Manual			37.481567 °	37.481567 °
				-121.046617 °	-121.046617 °
DWR ID	DWR_NA0065_15_t_2012_2				
Action/Comments					
Inspector Comments: The O&M manual is kept on site at the plant.

View of O&M manual stored onsite. (2019)

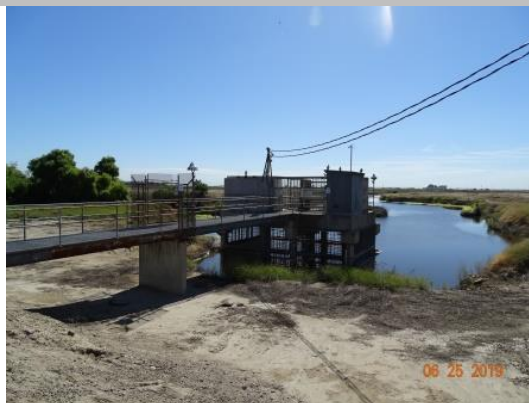
Photo 1 of 1 : ST\_2019\_NA0065\_15\_3\_20190627\_00021.jpg

LM Start	0.00	Rating **	A	Issue No.	3
LM End	0.00	Issue Type +	Ma	Location *	
Category	Pump Stations			GPS Latitude/Longitude	
				Start	End
Item	Plant Building			37.481567 °	37.481567 °
				-121.046617 °	-121.046617 °
DWR ID	DWR_NA0065_15_t_2012_3				
Action/Comments					
Inspector Comments: The plant building appeared to be in good structural condition with no significant concrete damage.

View of the pumping plant. (2019)

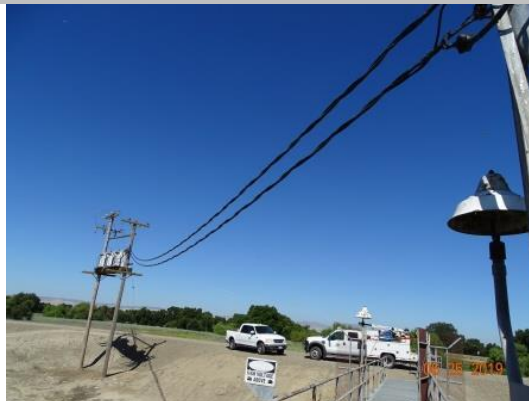
Photo 1 of 1 : ST\_2019\_NA0065\_15\_8\_20190627\_00022.jpg

LM Start	0.00	Rating **	A	Issue No.	8	
LM End	0.00	Issue Type +	Ma	Location *		
Category	Pump Stations			GPS Latitude/Longitude		
				Start	End	
Item	Power			37.481567 °	37.481567 °	
				-121.046617 °	-121.046617 °	
DWR ID	DWR_NA0065_15_t_2012_8					
Action/Comments						
Inspector Comments: Power delivered via the power grid. Appears to be adequate and reliable.

View of the power source at the plant. (2019)

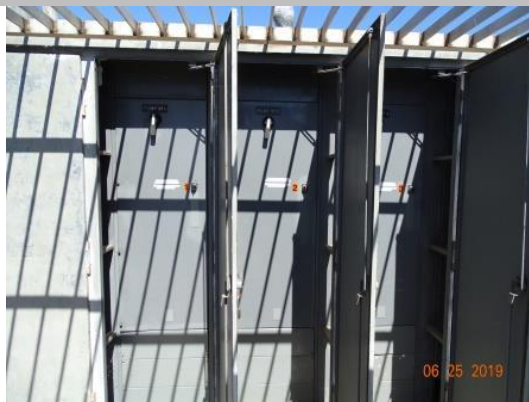
Photo 1 of 2 : ST\_2019\_NA0065\_15\_11\_20190627\_00023.jpg

LM Start	0.00	Rating **	A	Issue No.	11
LM End	0.00	Issue Type +	Ma	Location *	
Category	Pump Stations			GPS Latitude/Longitude	
				Start	End
Item	Pump Control Systems			37.481567 °	37.481567 °
				-121.046617 °	-121.046617 °
DWR ID	DWR_NA0065_15_t_2012_11				
Action/Comments					
Inspector Comments: The pump control system was operational and appeared to be free of any damage or corrosion.

View of the pump control boxes. (2019)

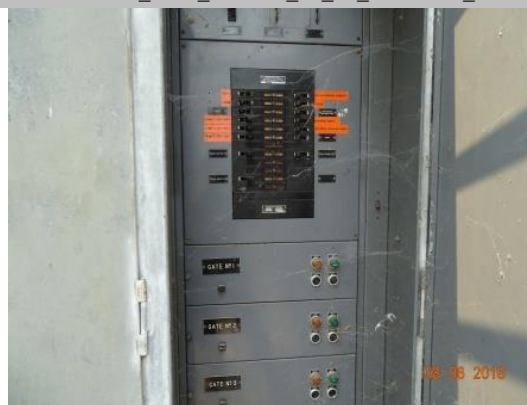
Photo 2 of 2 : ST\_2019\_NA0065\_15\_11\_20190613\_00009.jpg

LM Start	0.00	Rating **	A	Issue No.	11 (cont)
LM End	0.00	Issue Type +	Ma	Location *	
Category	Pump Stations			GPS Latitude/Longitude	
				Start	End
Item	Pump Control Systems			37.481567 °	37.481567 °
				-121.046617 °	-121.046617 °
DWR ID	DWR_NA0065_15_t_2012_11				
Action/Comments					
Inspector Comments: The pump control system was operational and appeared to be free of any damage or corrosion.

View of control panel. (2018)

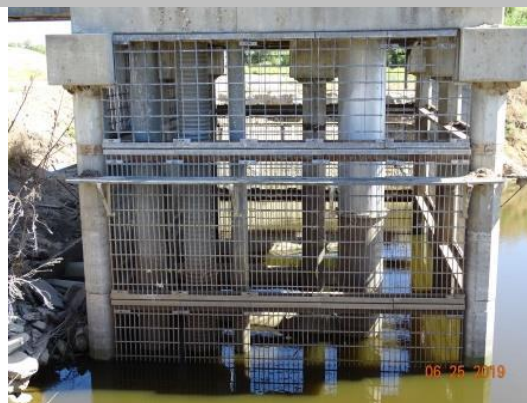
Photo 1 of 1 : ST\_2019\_NA0065\_15\_12\_20190627\_00024.jpg

LM Start	0.00	Rating **	A	Issue No.	12
LM End	0.00	Issue Type +	Ma	Location *	
Category	Pump Stations			GPS Latitude/Longitude	
				Start	End
Item	Sumps/Wet Well			37.481567 °	37.481567 °
				-121.046617 °	-121.046617 °
DWR ID	DWR_NA0065_15_t_2012_12				
Action/Comments					
Inspector Comments: The sump well was clear of excessive debris and other obstructions.

View of the wet well. (2019)

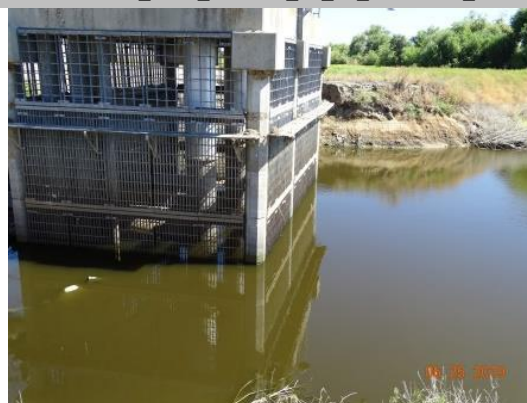
Photo 1 of 1 : ST\_2019\_NA0065\_15\_13\_20190628\_00025.jpg

LM Start	0.00	Rating **	A	Issue No.	13
LM End	0.00	Issue Type +	Ma	Location *	
Category	Pump Stations			GPS Latitude/Longitude	
				Start	End
Item	Trash Racks			37.481567 °	37.481567 °
				-121.046617 °	-121.046617 °
DWR ID	DWR_NA0065_15_t_2012_13				
Action/Comments					
Inspector Comments: The trash racks were free of debris and appeared to be maintained properly.

View of trash racks. (2019)

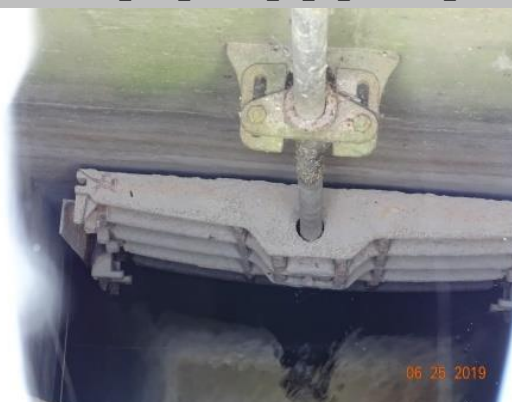
Photo 1 of 2 : ST\_2019\_NA0065\_15\_15\_20190628\_00026.jpg

LM Start	0.00	Rating **	A	Issue No.	15
LM End	0.00	Issue Type +	Ma	Location *	
Category	Pump Stations			GPS Latitude/Longitude	
				Start	End
Item	Sluice / Slide Gates			37.481567 °	37.481567 °
				-121.046617 °	-121.046617 °
DWR ID	DWR_NA0065_15_t_2012_15				
Action/Comments					
Inspector Comments: The slide gates were free of any debris and appeared to be in good working condition.

Typical view of slide gate at the outlet structure. (2019)

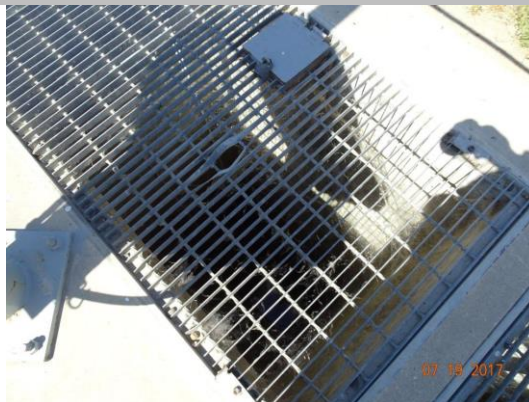
Photo 2 of 2 : ST\_2019\_NA0065\_15\_15\_20190613\_00013.jpg

View of the slide gate on the outlet structure. (2017)

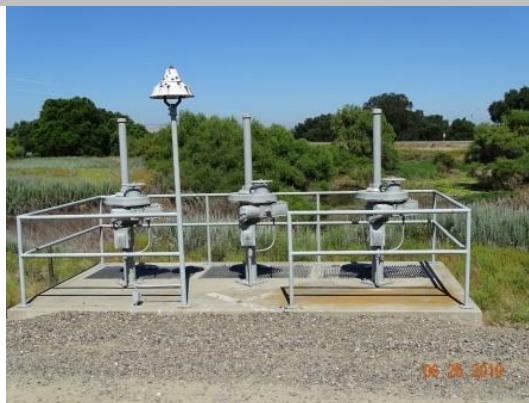
Photo 1 of 1 : ST\_2019\_NA0065\_15\_16\_20190628\_00027.jpg

LM Start	0.00	Rating **	A	Issue No.	16
LM End	0.00	Issue Type +	Ma	Location *	
Category	Pump Stations			GPS Latitude/Longitude	
				Start	End
Item	Electric Gate Operators			37.481567 °	37.481567 °
				-121.046617 °	-121.046617 °
DWR ID	DWR_NA0065_15_t_2013_16				
Action/Comments					
Inspector Comments: The electric gate operators were in good working condition.

View of electric gate operators. (2019)

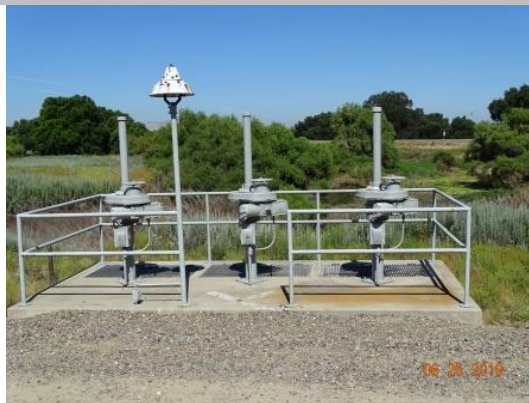
Photo 1 of 1 : ST\_2019\_NA0065\_15\_17\_20190701\_00032.jpg

LM Start	0.00	Rating **	A	Issue No.	17
LM End	0.00	Issue Type +	Ma	Location *	
Category	Pump Stations			GPS Latitude/Longitude	
				Start	End
Item	Manual Gate Operators			37.481567 °	37.481567 °
				-121.046617 °	-121.046617 °
DWR ID	DWR_NA0065_15_t_2012_17				
Action/Comments					
Inspector Comments: The manual gate operators appear maintained and in good working condition.

View of the gate operators. (2019)

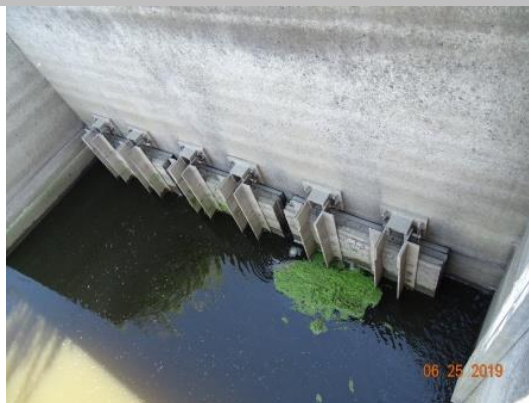
Photo 1 of 2 : ST\_2019\_NA0065\_15\_19\_20190628\_00029.jpg

LM Start	0.00	Rating **	A	Issue No.	19
LM End	0.00	Issue Type +	Ma	Location *	
Category	Pump Stations			GPS Latitude/Longitude	
				Start	End
Item	Flap Gates			37.481567 °	37.481567 °
				-121.046617 °	-121.046617 °
DWR ID	DWR_NA0065_15_t_2012_19				
Action/Comments					
Inspector Comments: The flap gates appeared to be in good working condition.

View of flap gates. (2019)

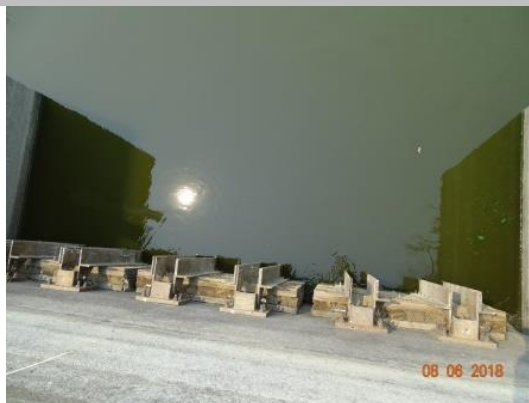
Photo 2 of 2 : ST\_2019\_NA0065\_15\_19\_20190613\_00015.jpg

View of flap gates. (2018)

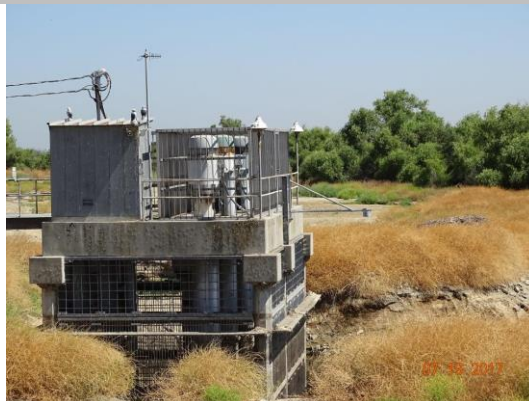
Photo 1 of 2 : ST\_2019\_NA0065\_15\_21\_20190613\_00016.jpg

LM Start	0.00	Rating **	A	Issue No.	21
LM End	0.00	Issue Type +	Ma	Location *	
Category	Pump Stations			GPS Latitude/Longitude	
				Start	End
Item	Security Fencing			37.481567 °	37.481567 °
				-121.046617 °	-121.046617 °
DWR ID	DWR_NA0065_15_t_2012_21				
Action/Comments					
Inspector Comments: The security fencing appeared to be in good condition and should provide protection against unauthorized access.

View of the steel cage around the pumps on the structure. (2017)

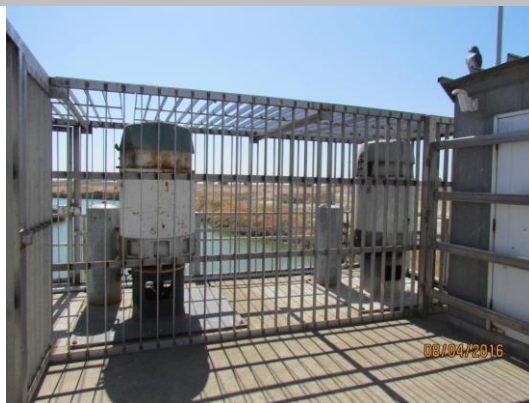
Photo 2 of 2 : ST\_2019\_NA0065\_15\_21\_20190613\_00017.jpg

View of the steel cage inside the plant. (2016)

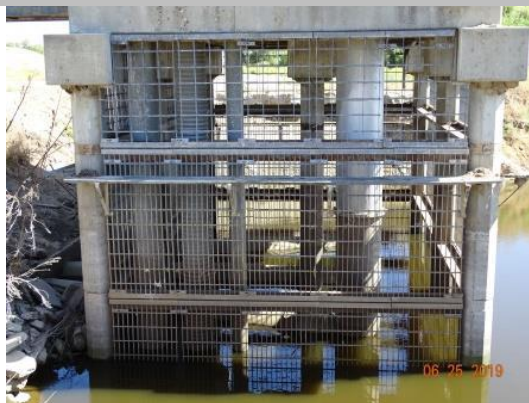
Photo 1 of 2 : ST\_2019\_NA0065\_15\_22\_20190628\_00030.jpg

LM Start	0.00	Rating **	A	Issue No.	22
LM End	0.00	Issue Type +	Ma	Location *	
Category	Pump Stations			GPS Latitude/Longitude	
				Start	End
Item	Intake and Discharge Pipes			37.481567 °	37.481567 °
				-121.046617 °	-121.046617 °
DWR ID	DWR_NA0065_15_t_2012_22				
Action/Comments					
Inspector Comments: The intake and discharge pipes appeared to be free of any breaks, holes or cracks.

View of intake and discharge pipes from left bank. (2019)

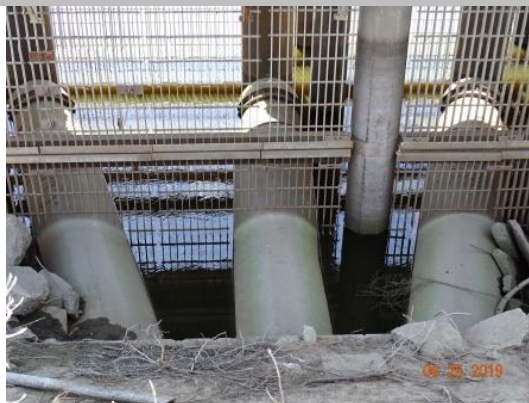
Photo 2 of 2 : ST\_2019\_NA0065\_15\_22\_20190628\_00031.jpg

LM Start	0.00	Rating **	A	Issue No.	22 (cont)
LM End	0.00	Issue Type +	Ma	Location *	
Category	Pump Stations			GPS Latitude/Longitude	
				Start	End
Item	Intake and Discharge Pipes			37.481567 °	37.481567 °
				-121.046617 °	-121.046617 °
DWR ID	DWR_NA0065_15_t_2012_22				
Action/Comments					
Inspector Comments: The intake and discharge pipes appeared to be free of any breaks, holes or cracks.

View of the intake and discharge pipes looking upstream. (2019)

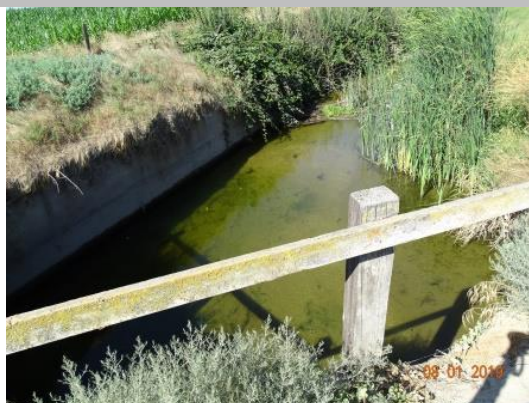
Photo 1 of 2 : ST\_2019\_NA0065\_70\_2\_20190808\_00027.jpg

LM Start	0.00	Rating **	M	Issue No.	2
LM End	0.00	Issue Type +	Ma	Location *	
Category	Structures & Concrete Lined Channels			GPS Latitude/Longitude	
				Start	End
Item	Vegetation & Obstructions			37.390522 °	37.390522 °
				-120.941096 °	-120.941096 °
DWR ID	DWR_NA0065_70_t_2017_2				
Action/Comments					
Inspector Comments: Moderate vegetation including cat tails was found in channel near all 3 components of this structure and should be managed to prevent degradation of channel capacity.

View of vegetation at the outlet of the siphon. (2019)

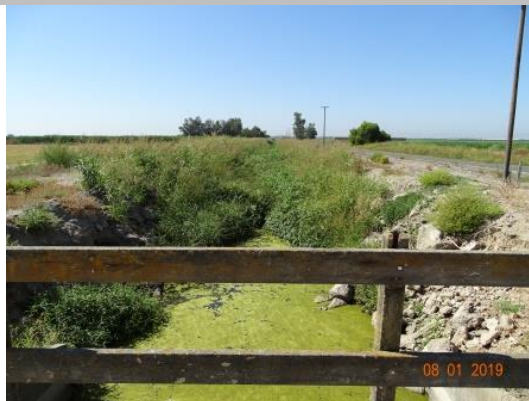
Photo 2 of 2 : ST\_2019\_NA0065\_70\_2\_20190808\_00028.jpg

View of vegetation downstream of lateral 6 gate. (37.406061, -120.940602) (2019)

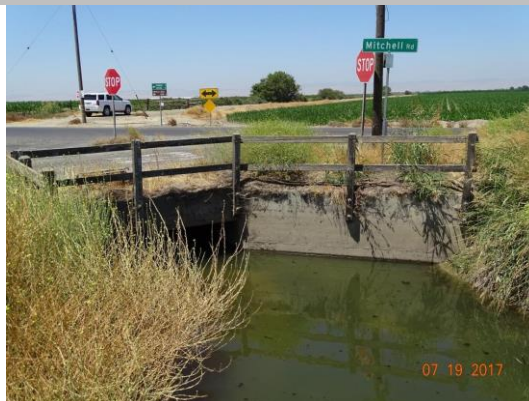
Photo 1 of 1 : ST\_2019\_NA0065\_70\_8\_20190613\_00012.jpg

LM Start	0.00	Rating **	A	Issue No.	8
LM End	0.00	Issue Type +	Ma	Location *	
Category	Structures & Concrete Lined Channels			GPS Latitude/Longitude	
				Start	End
Item	Culverts: Breaks / Holes / Cracks			37.390522 °	37.390522 °
				-120.941096 °	-120.941096 °
DWR ID	DWR_NA0065_70_t_2017_8				
Action/Comments					
Inspector Comments: No significant damage was found at the culverts.

View of the inlet culvert at the siphon structure looking west.

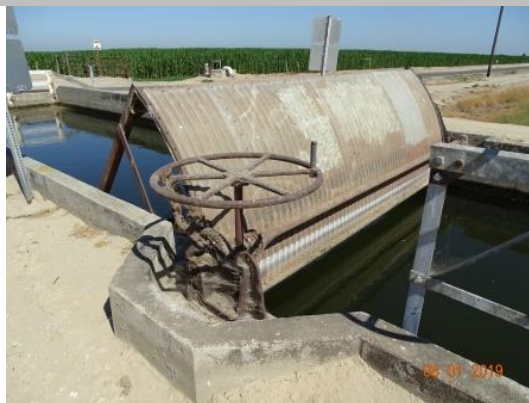
Photo 4 of 5 : ST\_2019\_NA0065\_70\_12\_20190808\_00036.jpg

View of the radial gate at lateral 6. (37.406061, -120.940602) (2018)

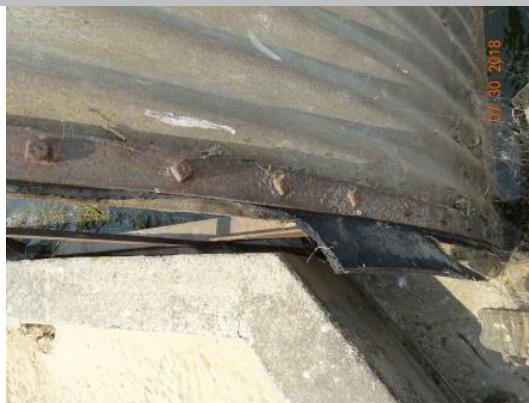
Photo 5 of 5 : ST\_2019\_NA0065\_70\_12\_20190613\_00017.jpg

LM Start	0.00	Rating **	A	Issue No.	12 (cont)	
LM End	0.00	Issue Type +	Ma	Location *		
Category	Structures & Concrete Lined Channels			GPS Latitude/Longitude		
				Start	End	
Item	Sluice/Slide Gates			37.390522 °	37.390522 °	
				-120.941096 °	-120.941096 °	
DWR ID	DWR_NA0065_70_t_2017_12					
Action/Comments						
Inspector Comments: Lateral 6 (37.406061,-120.940602) and lateral 7 (37.394123,-120.940805) control gates divert the water through the siphon structure during flood flow stage. The gasket on the radial gate at lateral 6 has deteriorated and should be replaced.

Deteriorated gasket on radial gate at lateral 6 should be replaced. (2018)

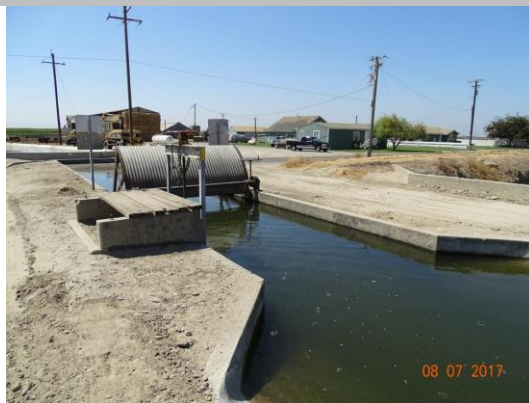
Photo 1 of 2 : ST\_2019\_NA0065\_70\_14\_20190613\_00018.jpg

LM Start	0.00	Rating **	A	Issue No.	14
LM End	0.00	Issue Type +	Ma	Location *	
Category	Structures & Concrete Lined Channels			GPS Latitude/Longitude	
				Start	End
Item	Manual Gate Operators			37.390522 °	37.390522 °
				-120.941096 °	-120.941096 °
DWR ID	DWR_NA0065_70_t_2017_14				
Action/Comments					
Inspector Comments: Manual gates at lateral 6 (37.406061,-120.940602) and lateral 7 (37.394123,-120.940805) should be greased, but are in working condition.

View of the manual gate at lateral 7. (2017)

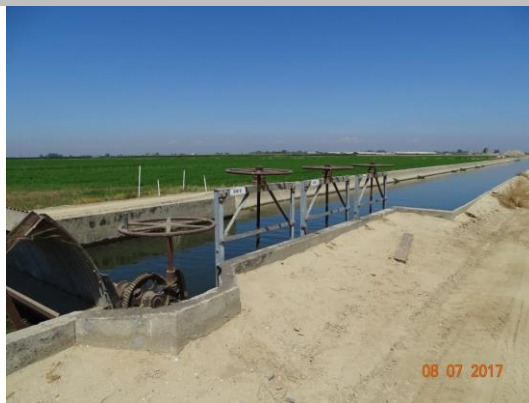
Photo 2 of 2 : ST\_2019\_NA0065\_70\_14\_20190613\_00019.jpg

View of the manual gates at lateral 6. (2017)

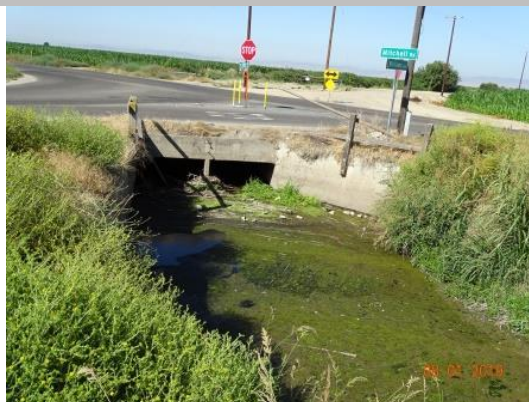
Photo 1 of 3 : ST\_2019\_NA0065\_70\_23\_20190808\_00038.jpg

Wooden railing at inlet side of siphon structure have fallen off posts.  
(2019)
